Ocotillo Road Bridge at Queen Creek Wash

Premier's Role

Monitoring Program

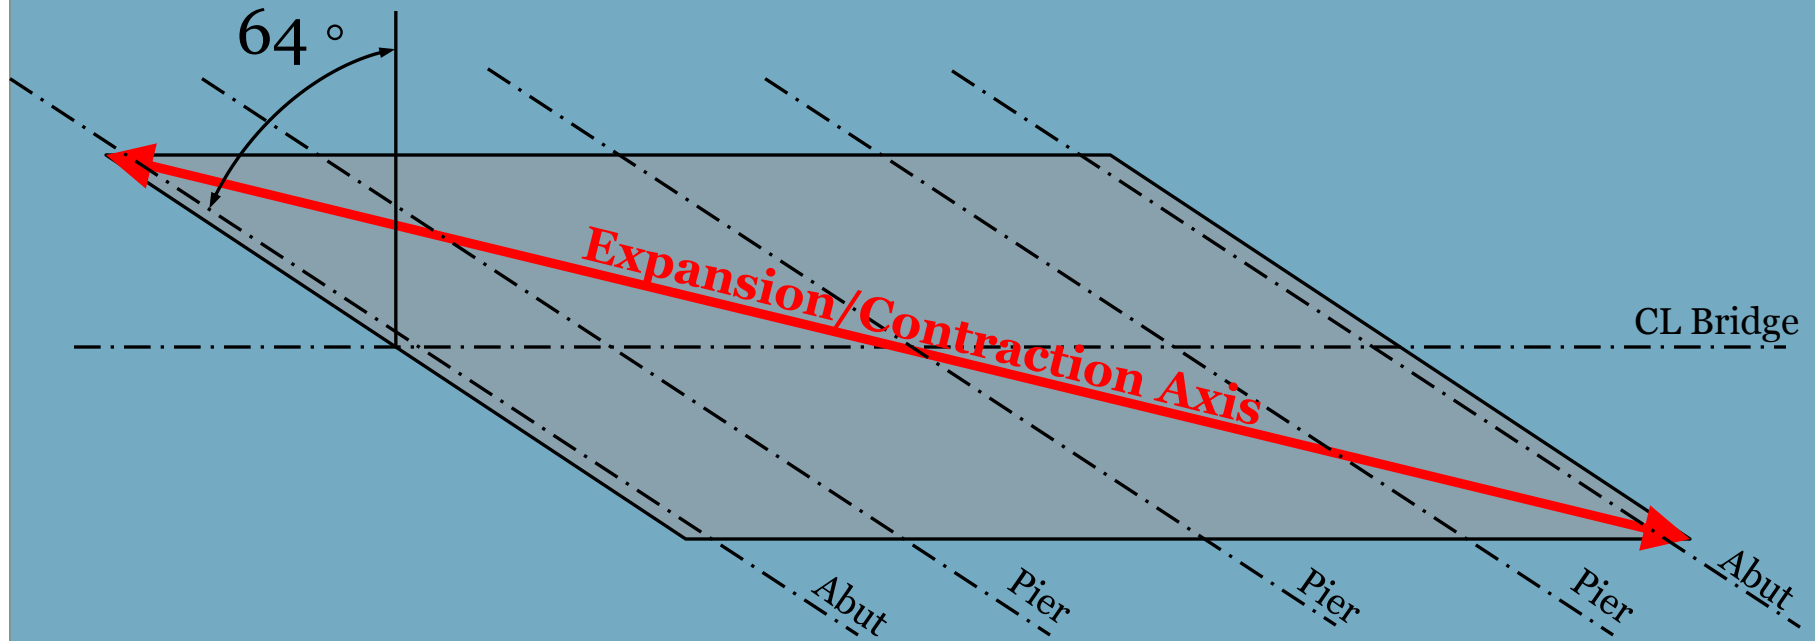
Bridge Expansion/Contraction

- Ocotillo Road Bridge

- The stiffness of the piers is restricting the expansion and contraction of the deck
- The bridge is finding its own way of relieving internal stresses, by opening and closing the cracks
- Previous recommendation to convert the abutments to expansion abutments is not likely to solve the problems in Spans 2 and 3

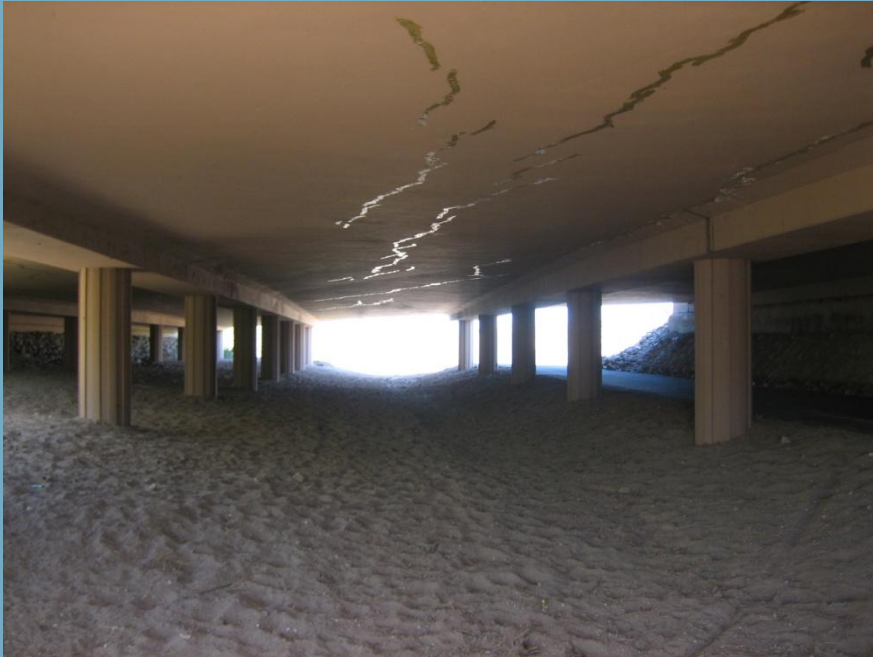
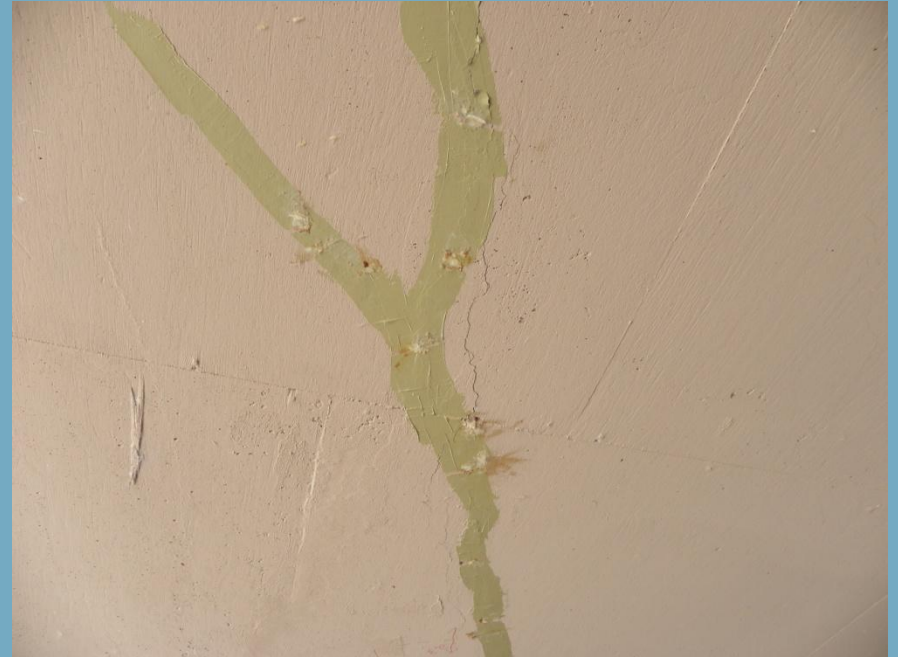
- Major cracks were injected with epoxy sealant in 2005

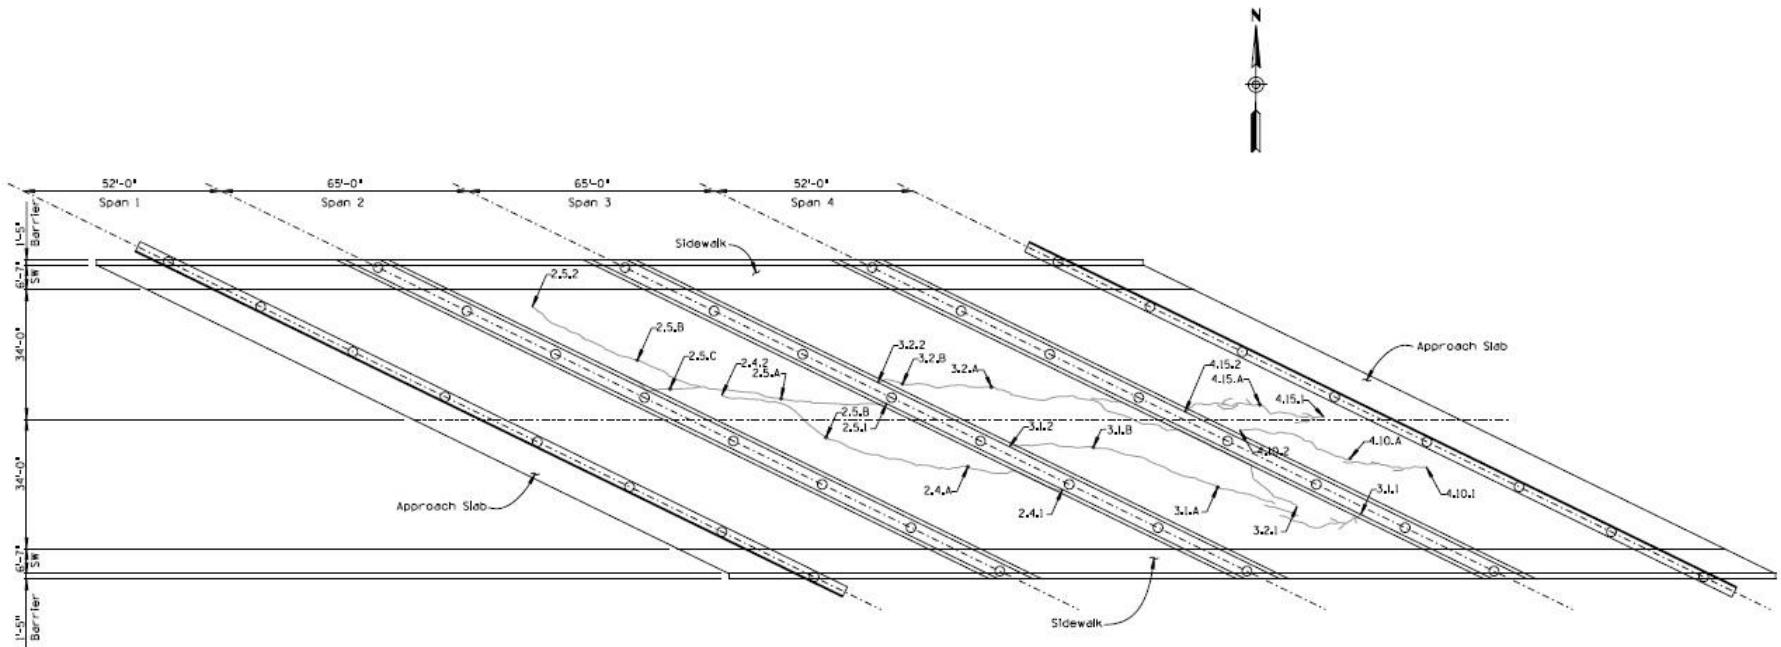
- Existing crack locations were mapped

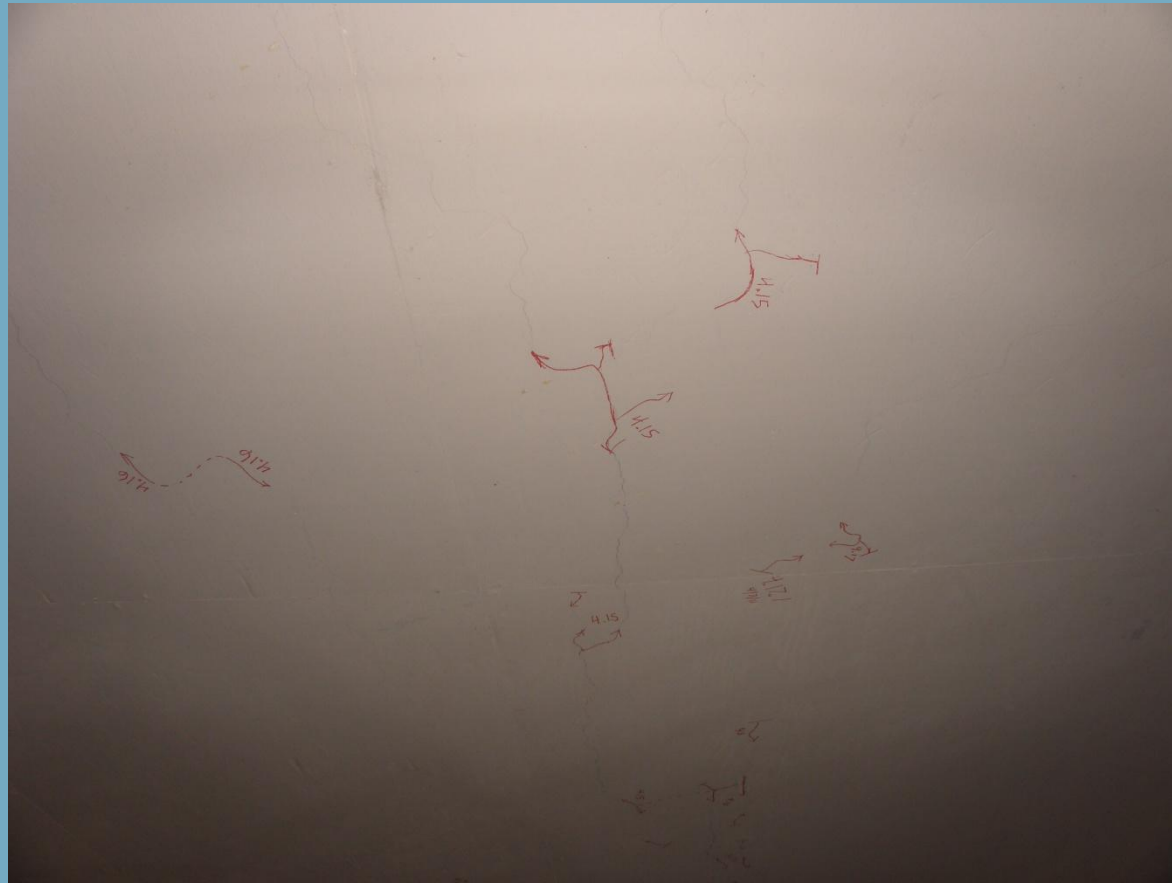
- Cracks were marked directly on the bridge in **RED**

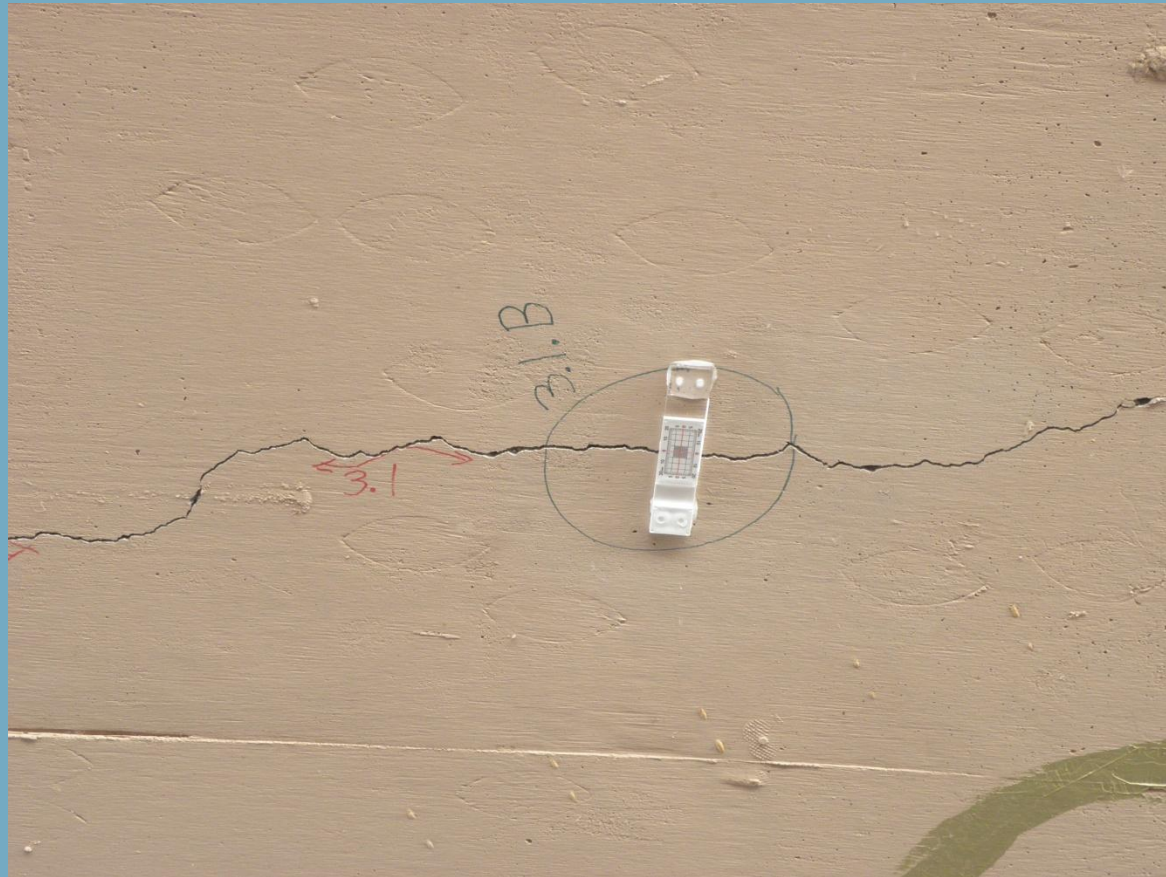
- 11 crack gauges were installed

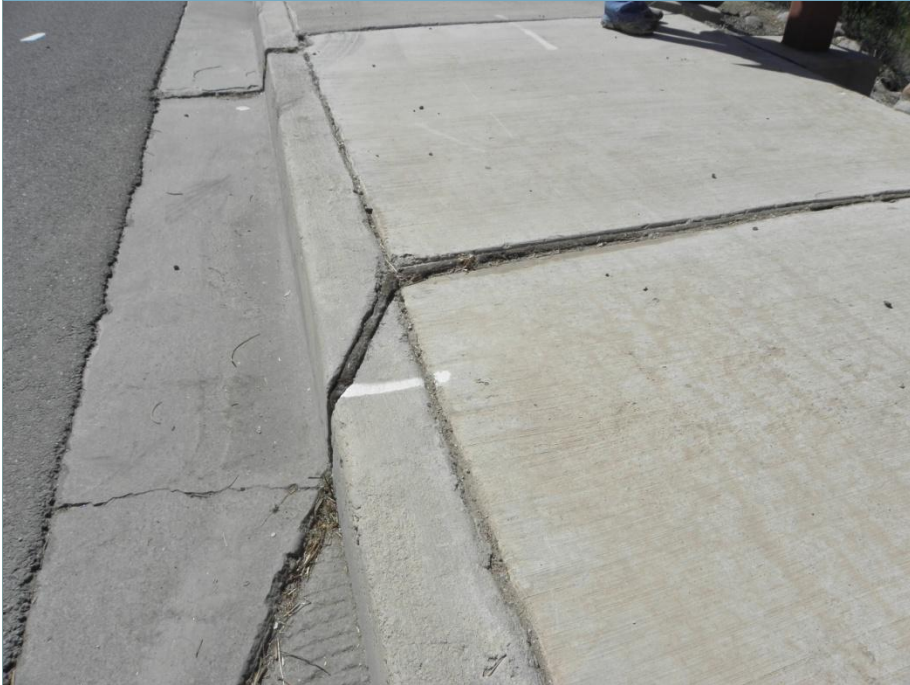
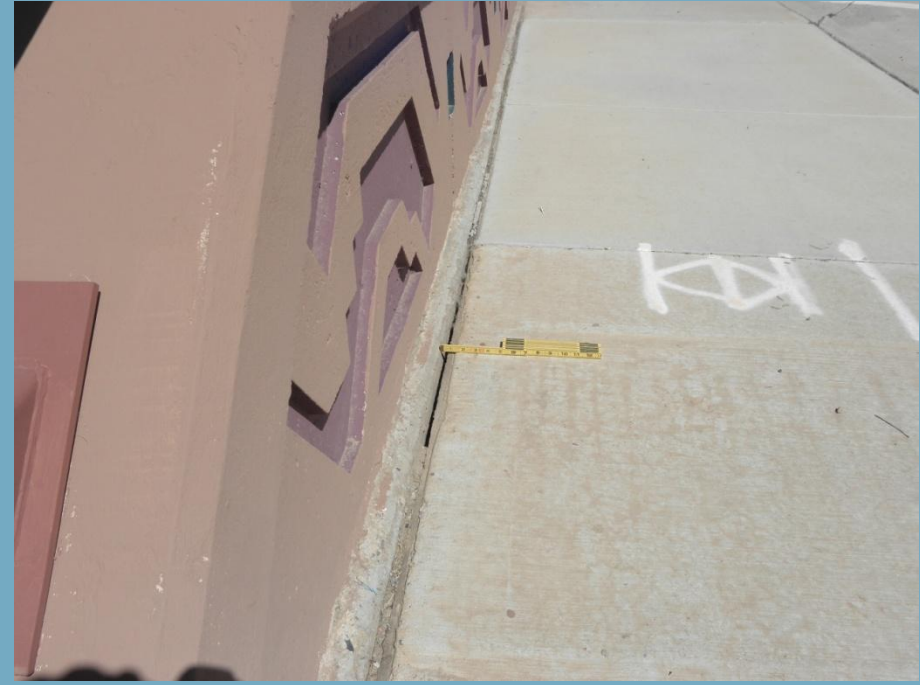
- Settlement and movement of sidewalks was documented

- No change in settlement or movement of sidewalks at corners of bridge during the monitoring period
- Cracks in Spans 2 and 3 decreased in width (closed up) during low temperatures
- Some hairline cracks grew in length and/or formed new legs during high temperatures
- No new major cracks formed, indicating possible stable conditions

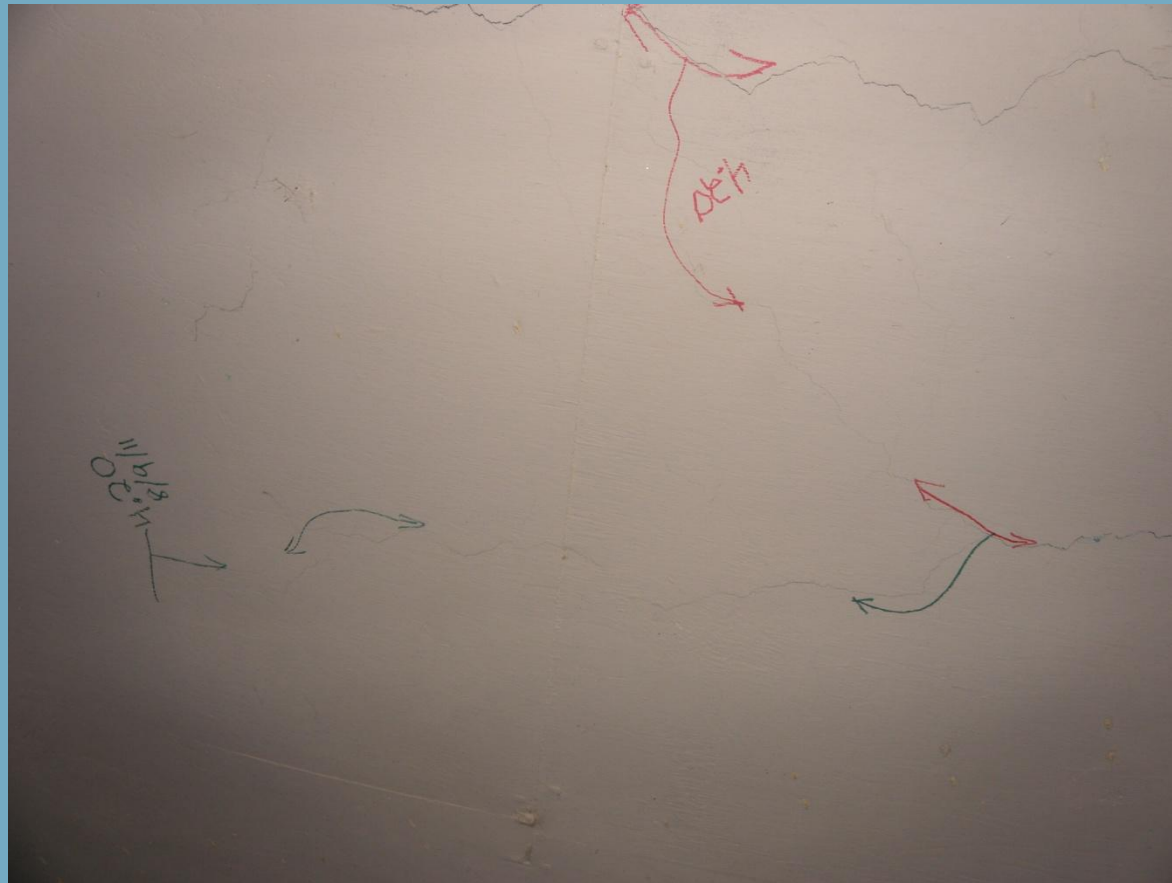
- Second inspection, August 2011
 - Temperature: 104 degrees
 - Documented changes in crack lengths, density, etc.
 - ✦ Some hairline cracks had grown in length
 - ✦ Some hairline cracks had formed new legs
 - Read crack gauges to determine any changes in crack widths
 - ✦ No major changes in crack widths were found

- Changes in cracks were marked in **GREEN**

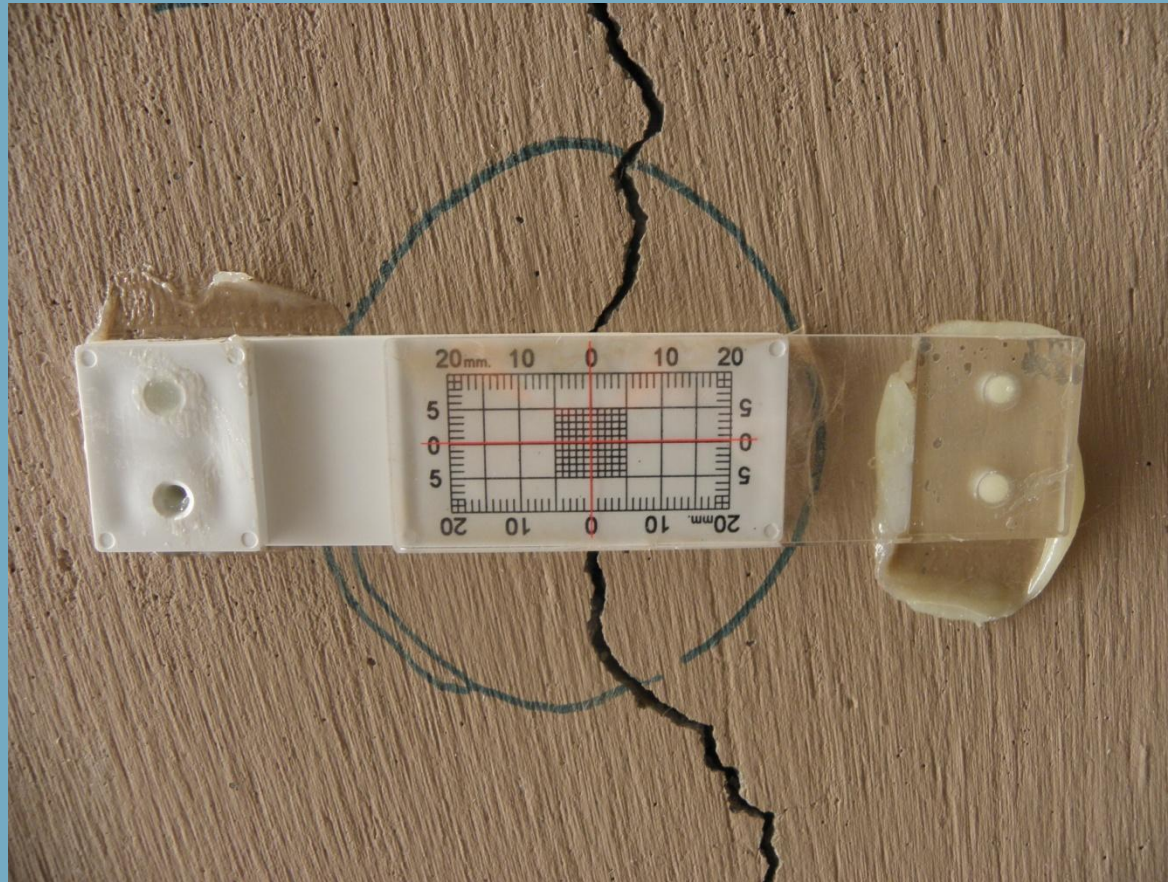
- Crack gauges (0.00 mm movement)

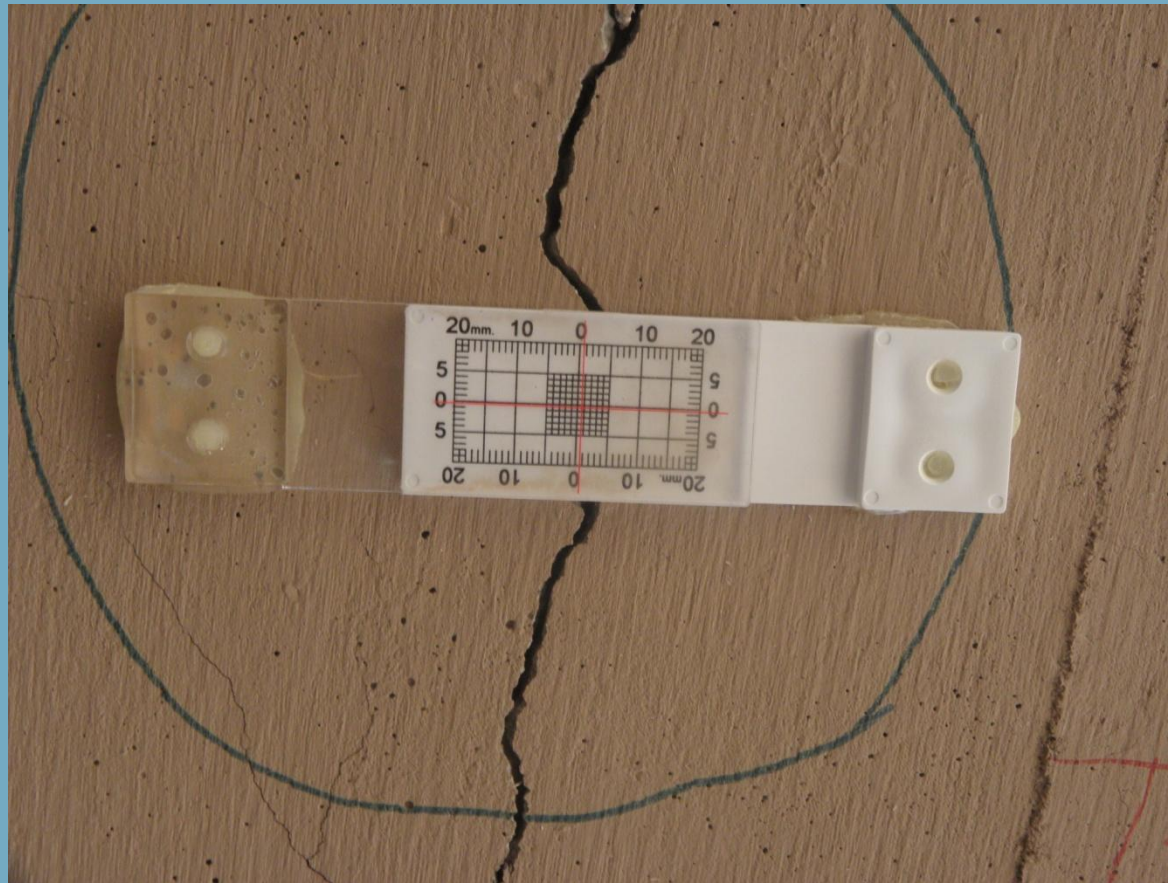
- Third inspection, February 2012
 - Temperature: 39 degrees
 - Documented changes in crack lengths, density, etc.
 - ✦ No cracks had grown in length
 - ✦ No cracks had formed new legs
 - Read crack gauges to determine any changes in crack width
 - ✦ 4 gauges showed 0.75 mm of crack width contraction
 - ✦ 1 gauge showed 0.50 mm of crack width contraction

- Crack gauges (0.75 mm contraction)

- Seal the major cracks with a flexible sealant that will allow the cracks to open and close while preventing the infiltration of water
- Seal the entire deck with an overlay to prevent water from infiltrating into any smaller cracks
 - 1/2" Marshall Terminal Blend Asphalt overlay is recommended
 - Other impervious membranes are available
- Monitor the bridge during future routine inspections
- No additional work is required at this time
