Ironwood Road Road Safety Audit

Troy White, Public Works Director

3.20.19

Ironwood Road – Roadway Safety Audit

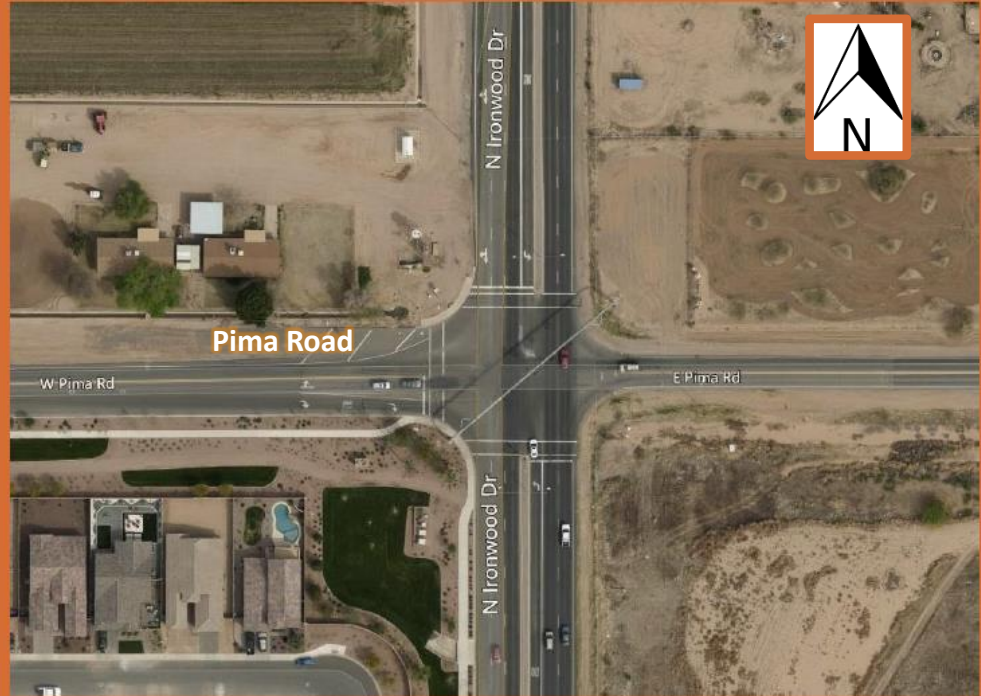
Findings – Traffic Signal Timing

- EB Left-Turn lane not clearing in one cycle during AM Peak.
- Recommend Split signal phasing initially.

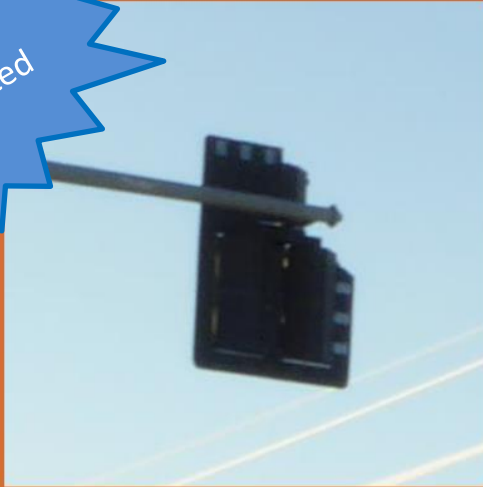
Findings – Broken Traffic Signal

Fix/replace damaged 5-section signal head on Germann west leg.

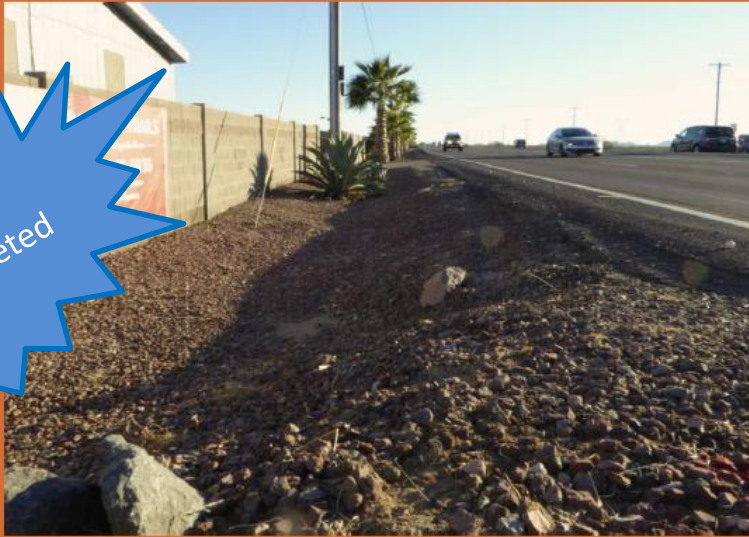
Findings – Shoulder Drop

Steep, unprotected shoulder just south of Germann Road on east side of Ironwood Drive.

Recommend grading, or maintenance

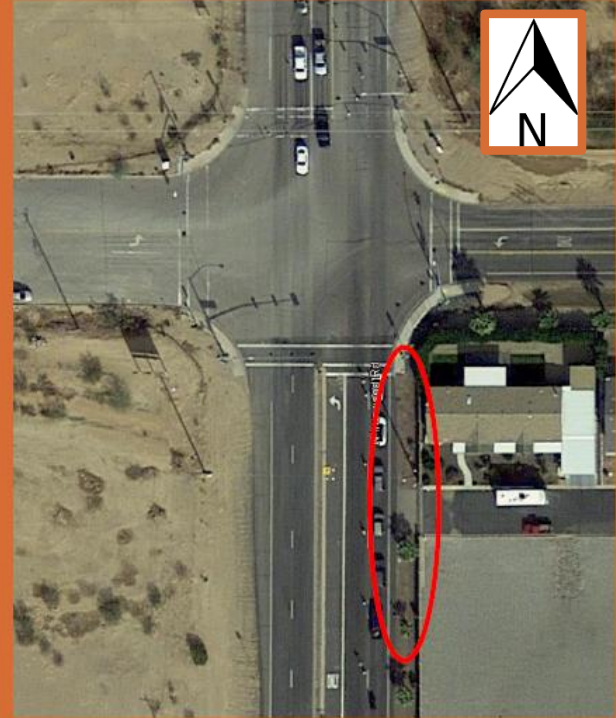
Findings – Missing Sidewalk Panel

Add sidewalk slab on east leg of Ocotillo & Ironwood.
Provide minimum 3' crossing width for ADA.

Referred
to Pinal
County

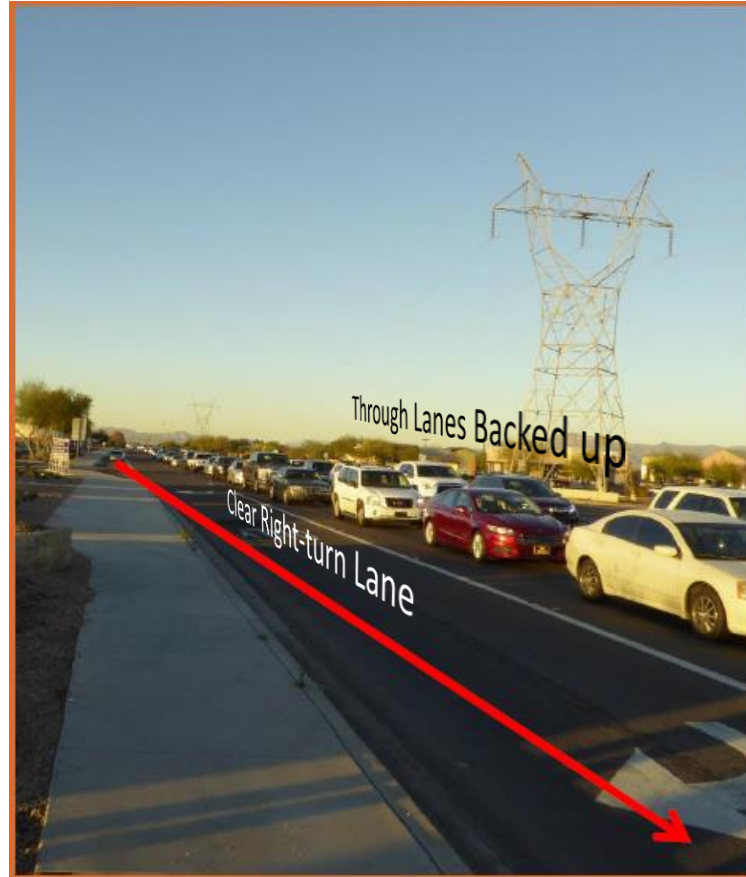
Findings – Ironwood Southbound Right-turn Lane North of Ocotillo Road

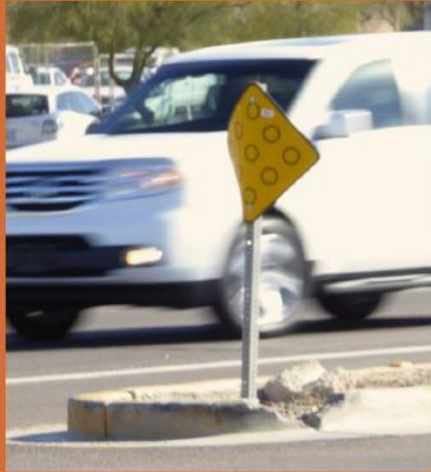
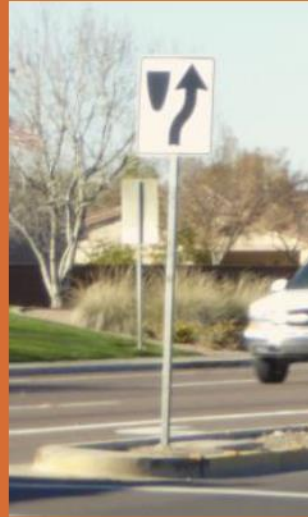
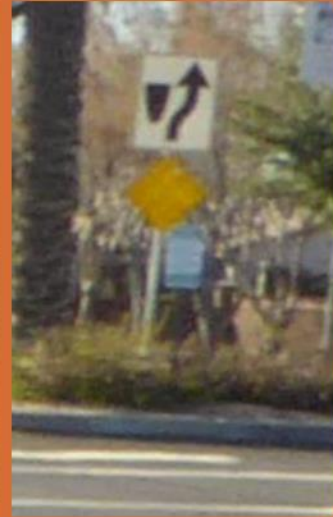
Findings - Signage, Curbs, Paint

- Place object markers and keep right signs consistently on all intersection medians and median openings.
- Refresh Yellow Paint on median noses.
- Repair damaged median curbs.

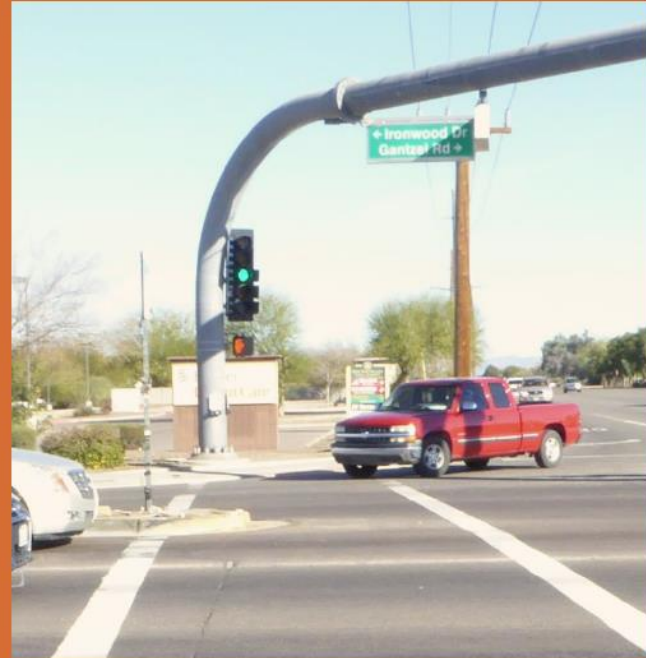
Findings – Signage, Curb, Paint (Continued)

North leg of Ironwood/Ocotillo Median extends into crosswalk.

- Recommend cutting curb back to avoid conflict with crosswalk.

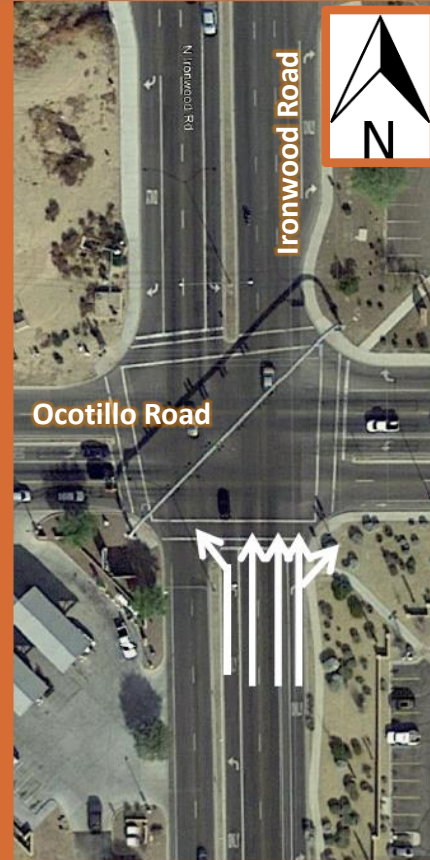
Findings – Right-Turn only lane should be Through-Lane

- Re-stripe northbound right-turn lane to be a thru/right-turn option.
- Right-turn lane would open up 900' before Ocotillo.
- Remove bike lane at McDonalds or move to inside
- Drivers already doing this.

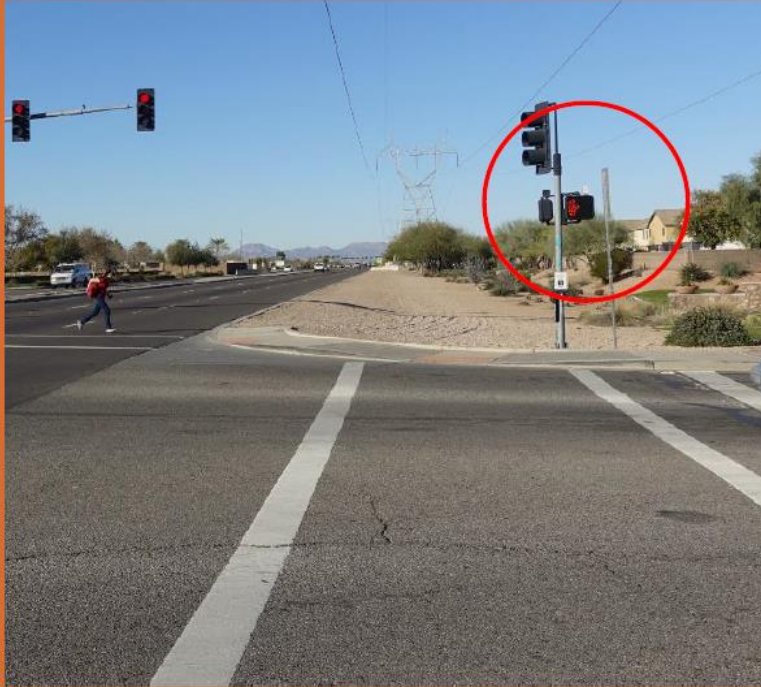
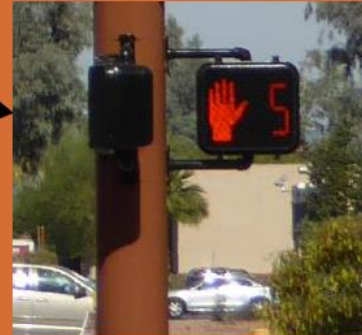
Findings – Pedestrian Countdown Signals

Show pedestrian countdown timer on pedestrian signals.

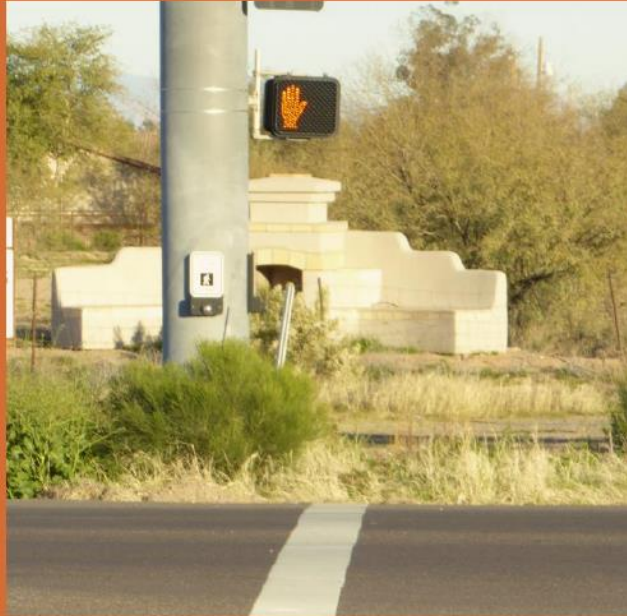
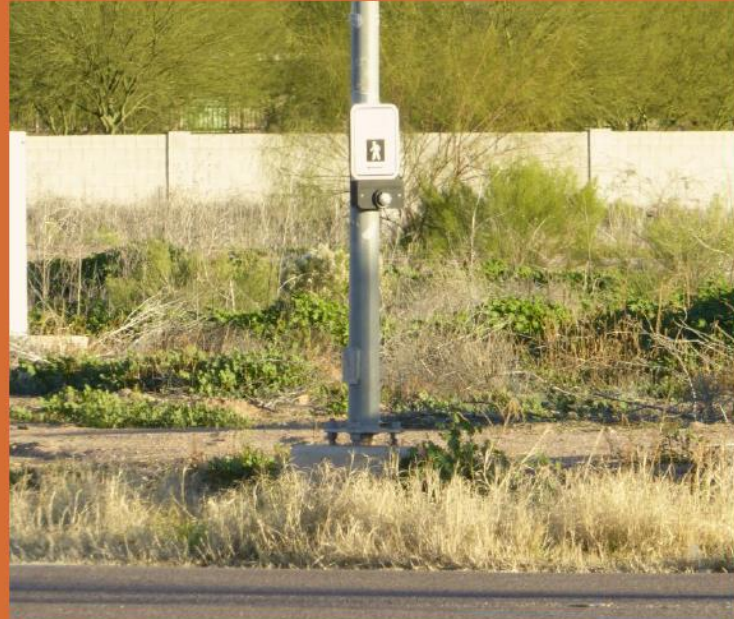
Findings – Pedestrian Ramps

No sidewalk ramps on east corners of Pima.

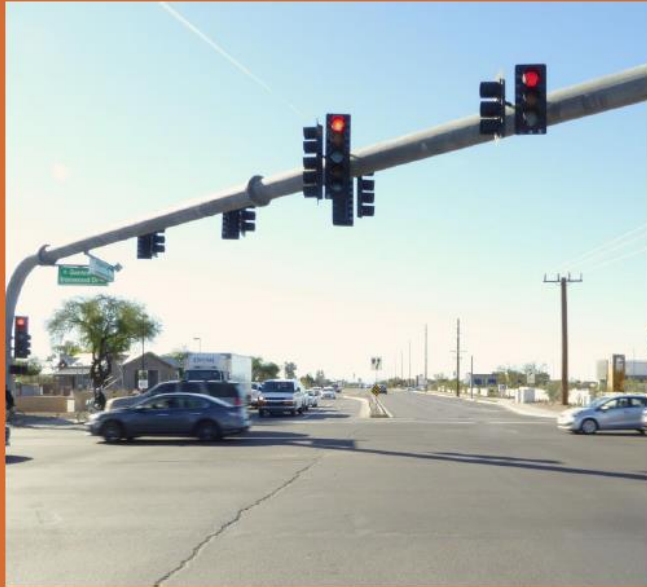
WB Ocotillo

Findings – Left-Turn Lanes

Left-Turn Lanes have negative offset at all signalized intersections.

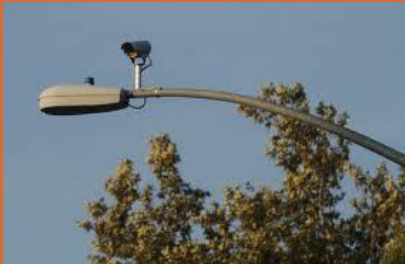
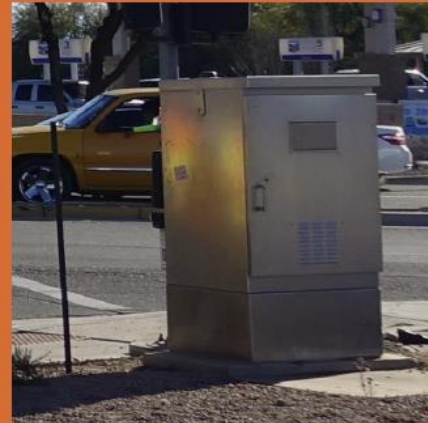
Findings – Traffic Signal Controller Cabinets

- Signal cabinets cannot be operated by police officers during an emergency.
- Recommend upgrading signal cabinets so police officers can cycle through phases during emergencies.
- Upgrade cabinets to support EVP.
- Install conduit and traffic cameras
- Connect Intersections to ITS

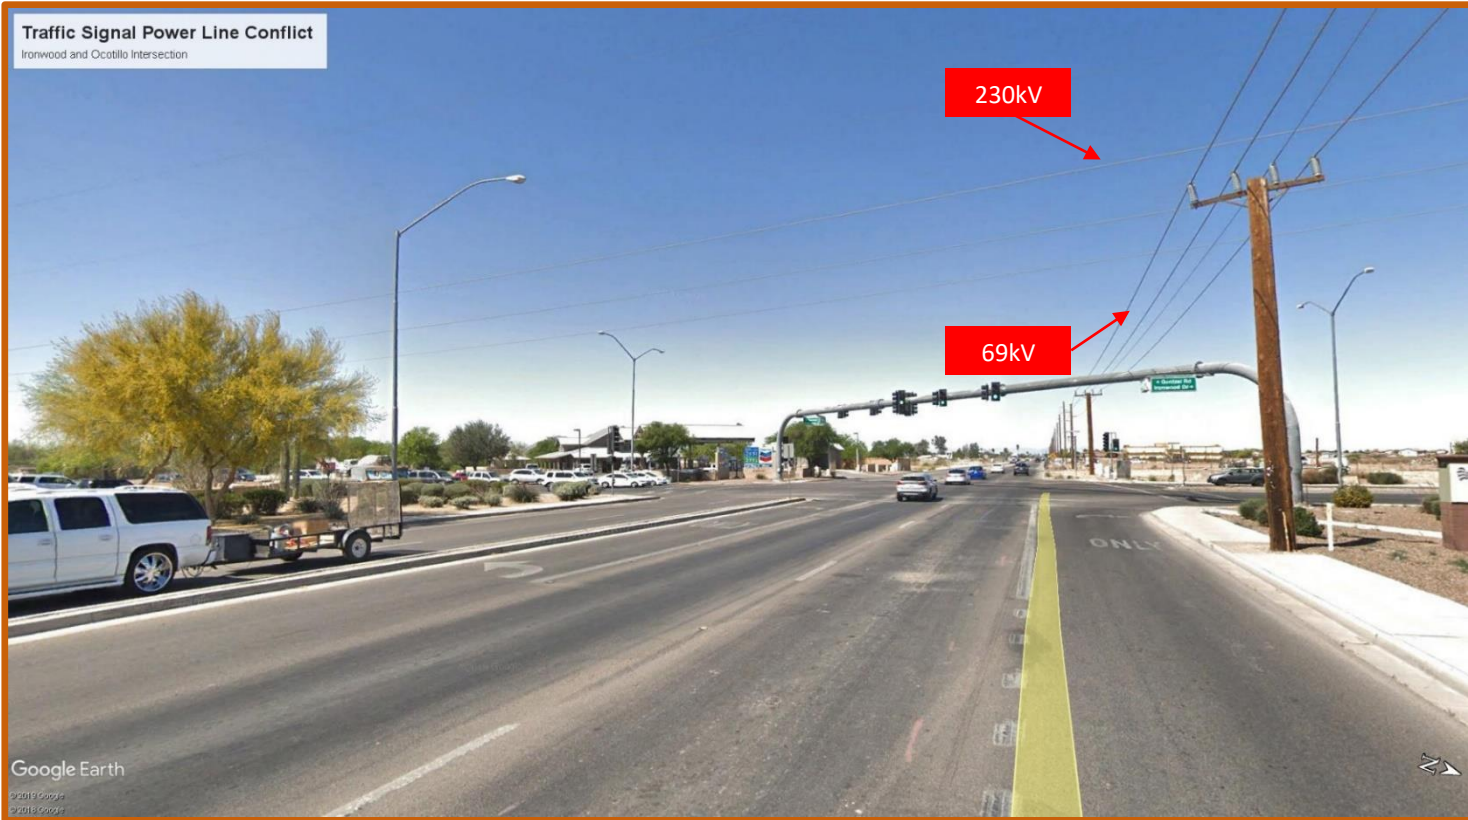
Traffic Signal Power Line Conflict
Ironwood and Ocotillo Intersection

Traffic Signal – Power Line Conflict
