Ironwood Road Road Safety Audit

Troy White, Public Works Director

3.20.19

Ironwood Road – Roadway Safety Audit

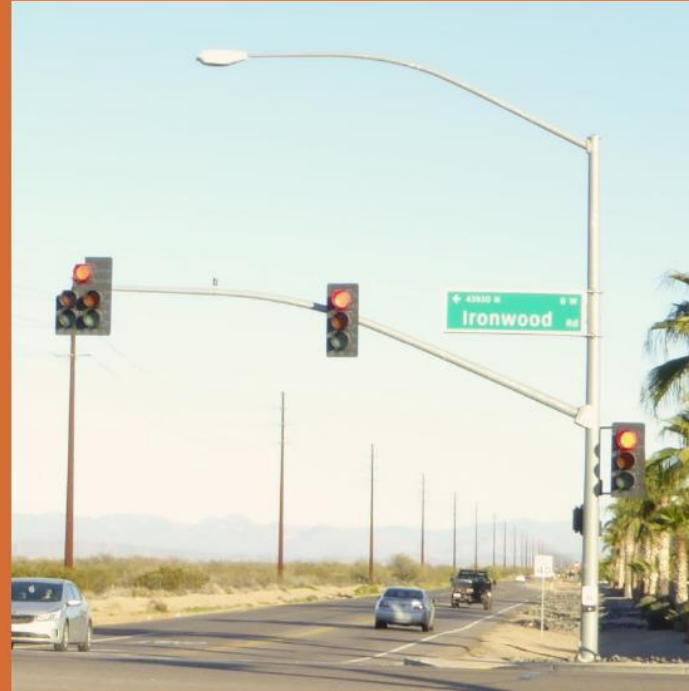
Findings – Shoulder Drop

Steep, unprotected shoulder just south of Germann Road on east side of Ironwood Drive.

Recommend grading, or maintenance

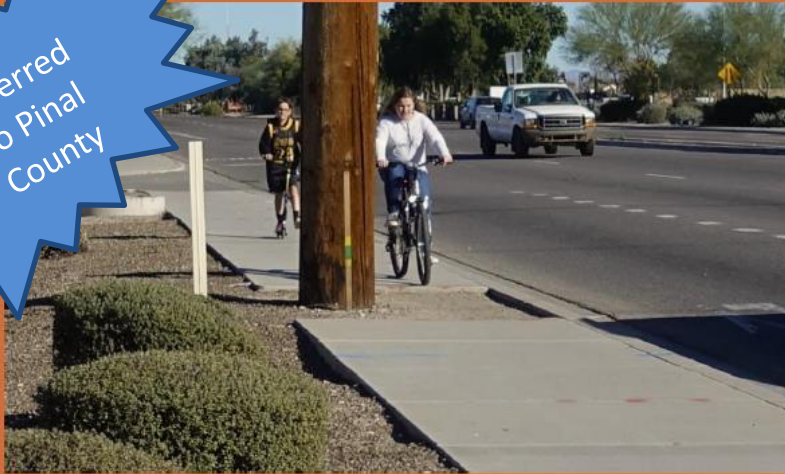
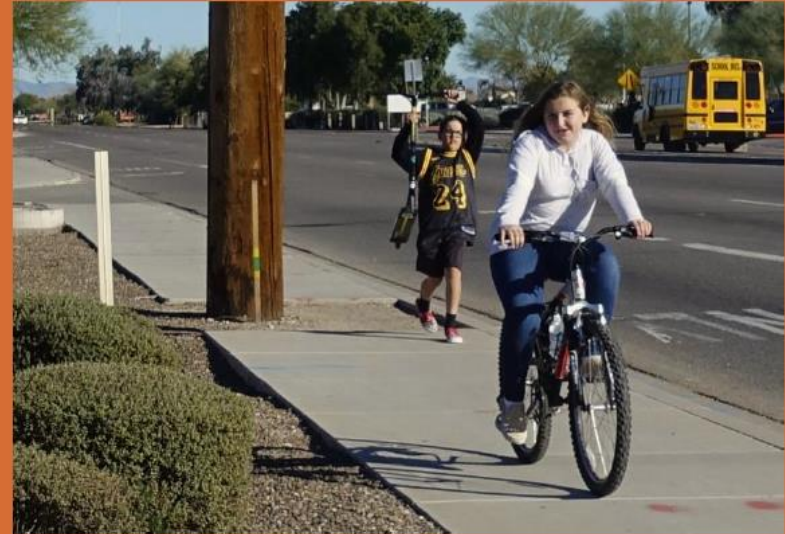
Findings – Missing Sidewalk Panel

Add sidewalk slab on east leg of Ocotillo & Ironwood.
Provide minimum 3' crossing width for ADA.

Referred
to Pinal
County

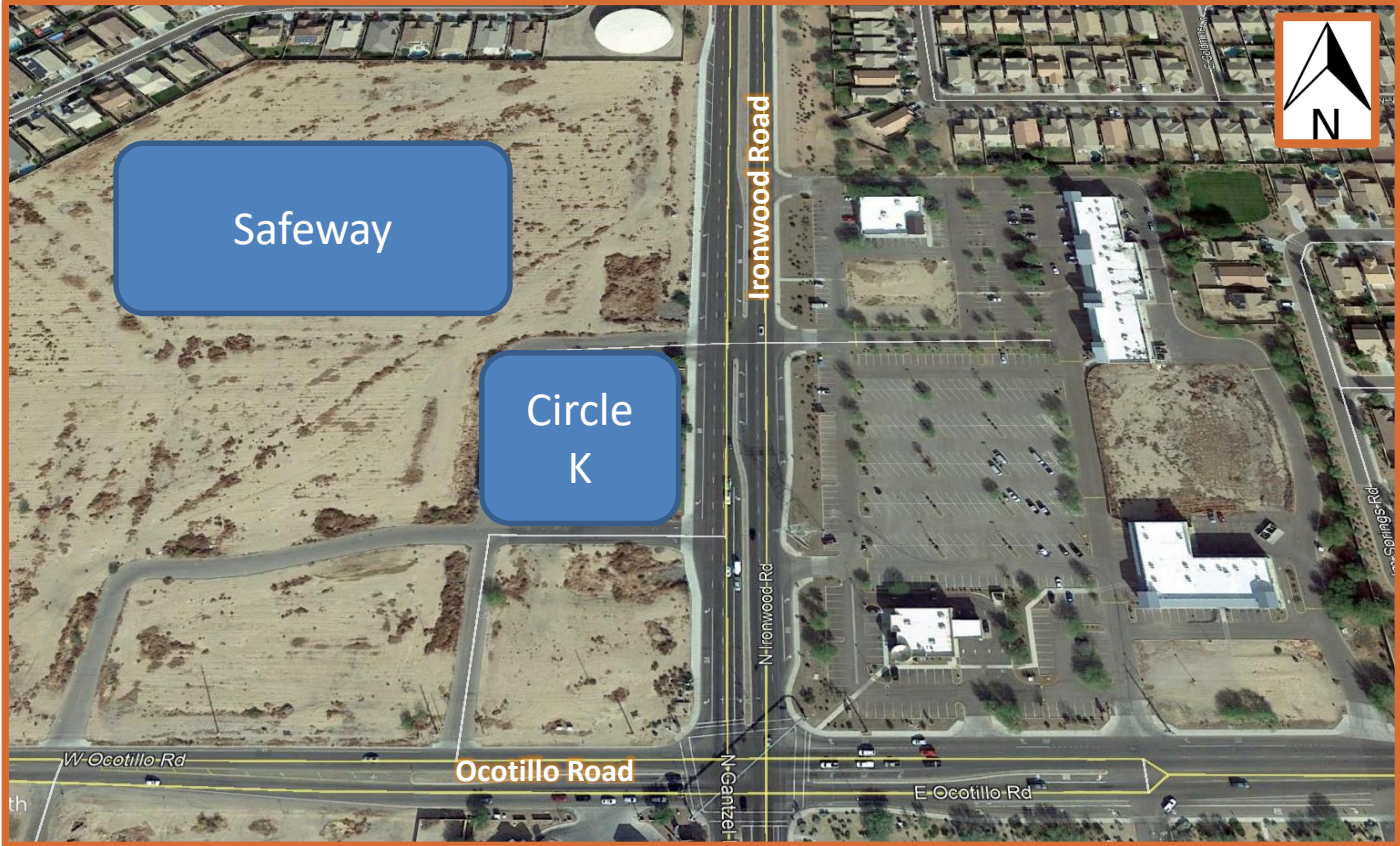
Findings – Ironwood Southbound Traffic

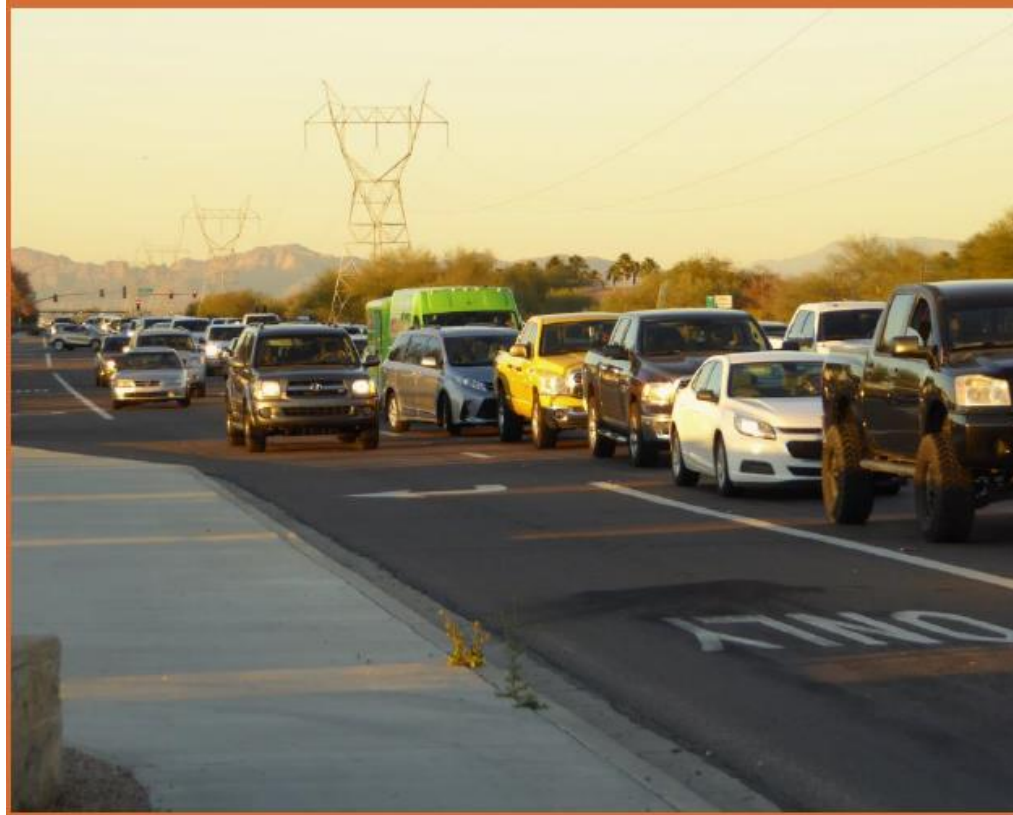
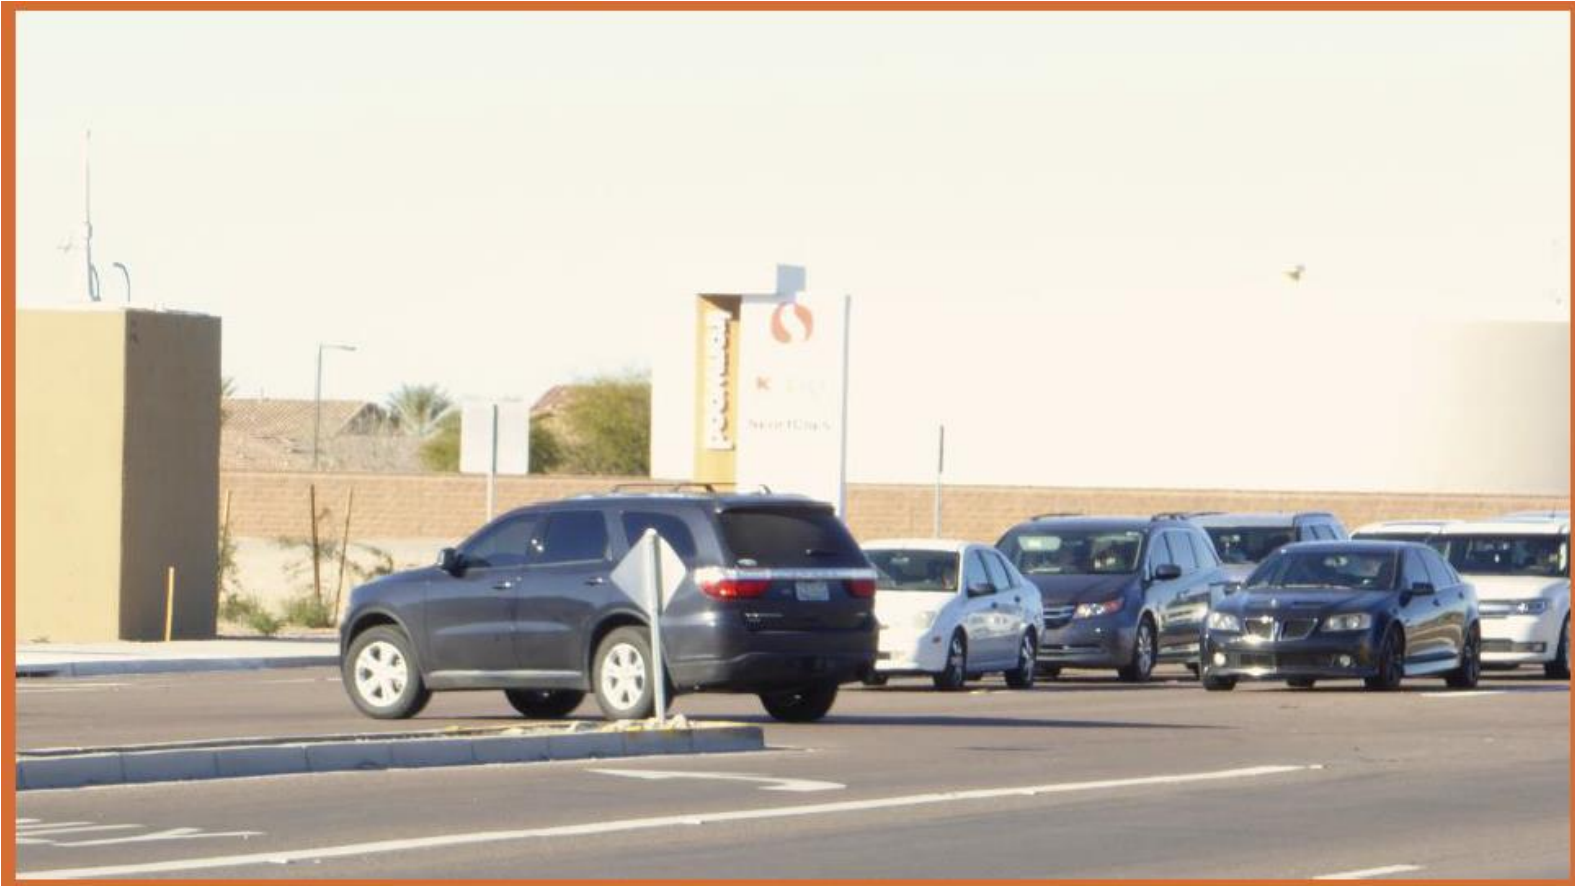
Findings – Ironwood Southbound Right-turn Lane North of Ocotillo Road

In Progress
\$25k

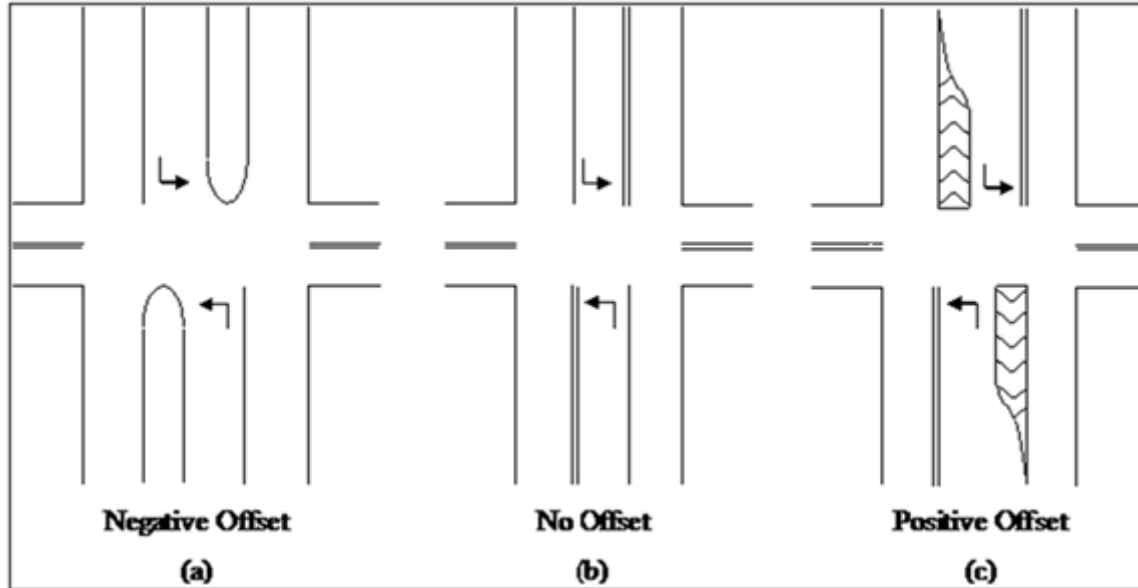
Left-turn Lanes

Findings – Left-Turn Lanes

Left-Turn Lanes have negative offset at all signalized intersections.

FY 2020
\$520k
